BULLETIN MK20A-004 Rev. B

APPLICABLE TO: MK20A Localizer LPD Antennas

SUBJECT: Gaskets on Rear Access Panel of MK20A Localizer LPD Antennas are installed incorrectly

EQUIPMENT AFFECTED: MK20A Localizer LPD Antennas with Welded Dipoles

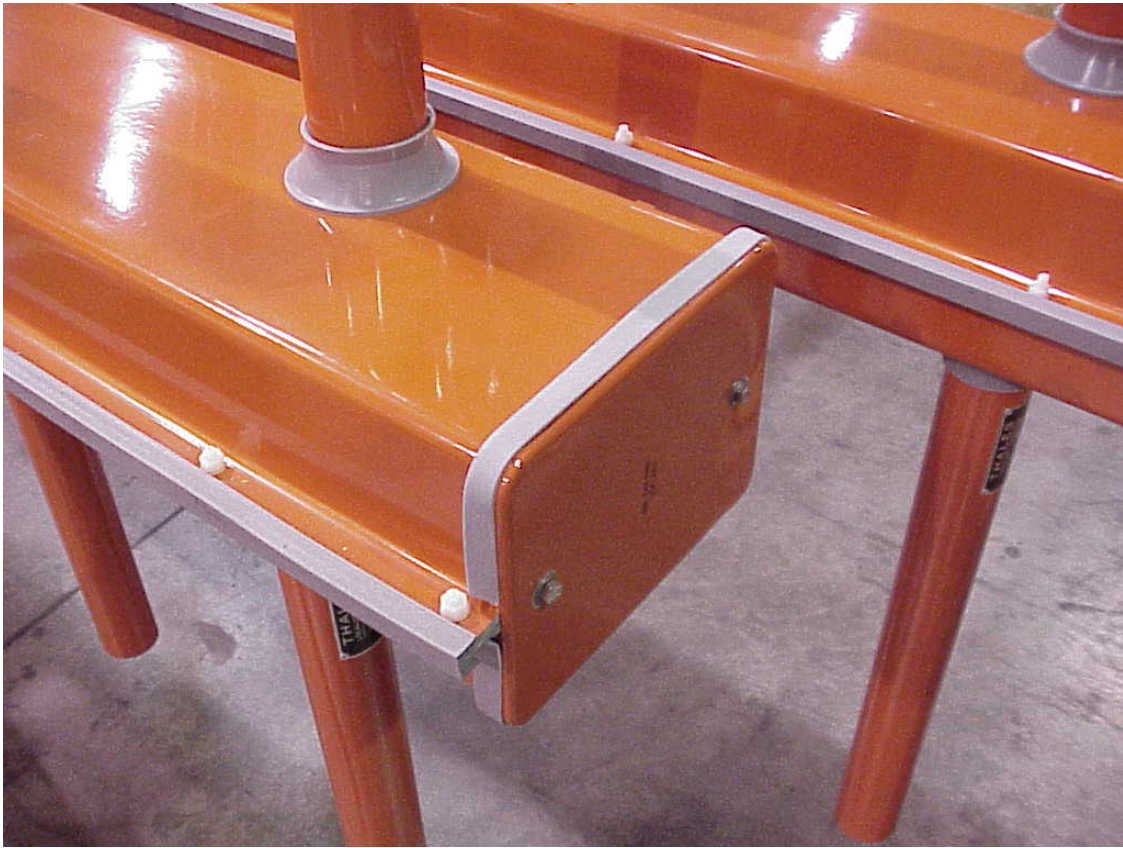
Thales has discovered that the gasket for the rear cover was not installed correctly on LPD Antennas manufactured after January 2010. Figure 1 illustrates an improper installation and Figure 3 illustrates a proper installation.

Figure 1.0. Example of Improper Installation of Gasket

1. Determine if the gasket is installed incorrectly (see Figure 1.0).
2. If so, remove the existing gasket from the access cover.
3. Reinstall the gasket on the lip of the weather shield (see Figure 2.0).
 - Notice that a notch will need to be added to the gasket where the 2 flanges meet.
 - The total length of the gasket should be 23". This will require the gasket to be shorted by 3".
4. Reinstall the access cover (see Figure 3.0).

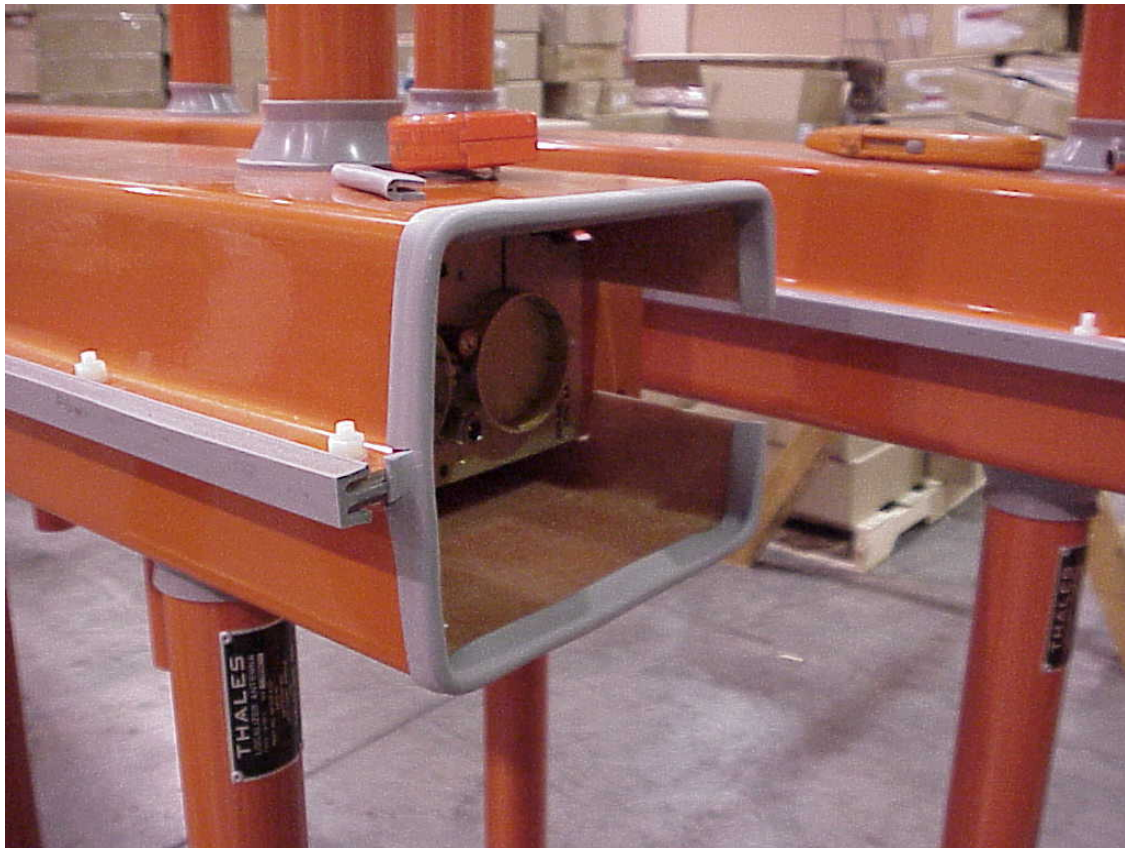
Figure 2.0. Example of Gasket Installation on Weather Shield Lip (with modifications made)

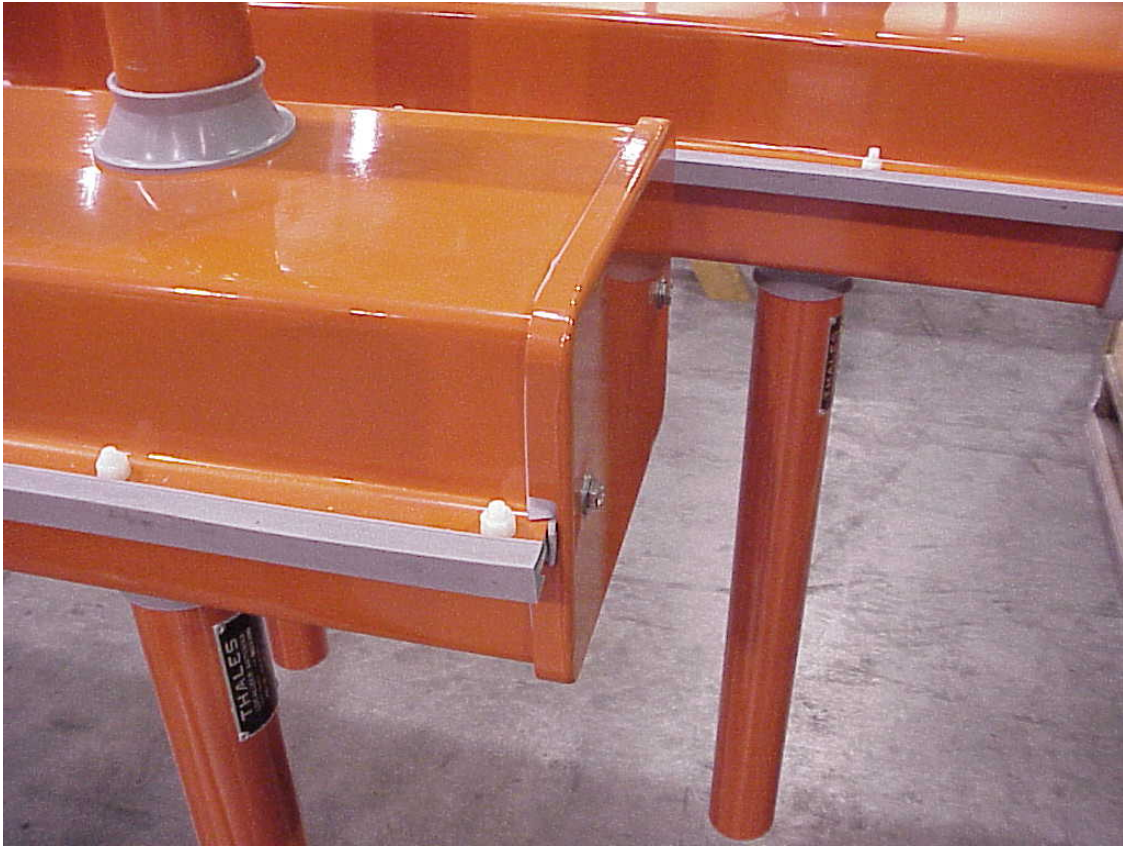
Figure 3.0. Example of Properly Installed Gasket
